**State of Louisiana
Department of Natural Resources
Coastal Engineering Division**

**2005/2006 Annual Inspection
Report**

**PECAN ISLAND TERRACING
PROJECT
(ME-14)**

October 20, 2005
Vermilion Parish

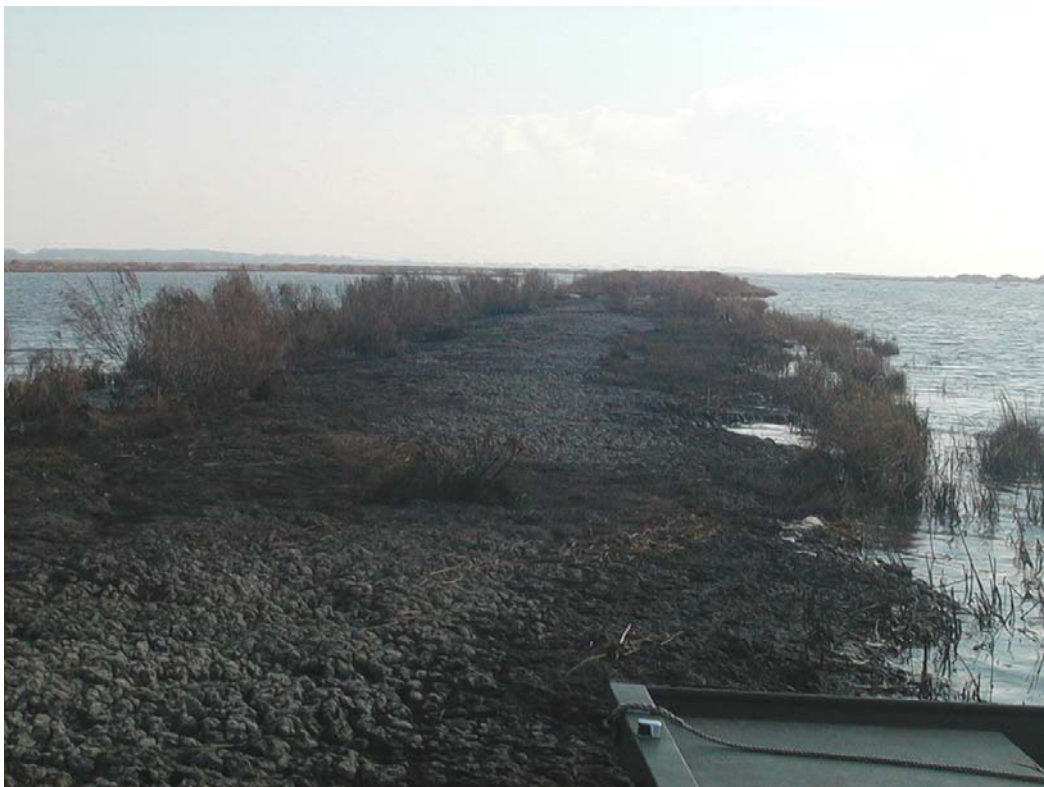
The earthen terraces are in very good condition and did not sustain damages from the storm. Anticipated erosion on the southern sacrificial terraces has occurred. However, those sacrificial terraces are still providing protection for the interior earthen terraces. No maintenance required at this time. (Photos: Appendix B, Photo 1)

Photo 1, Typical earthen terrace.

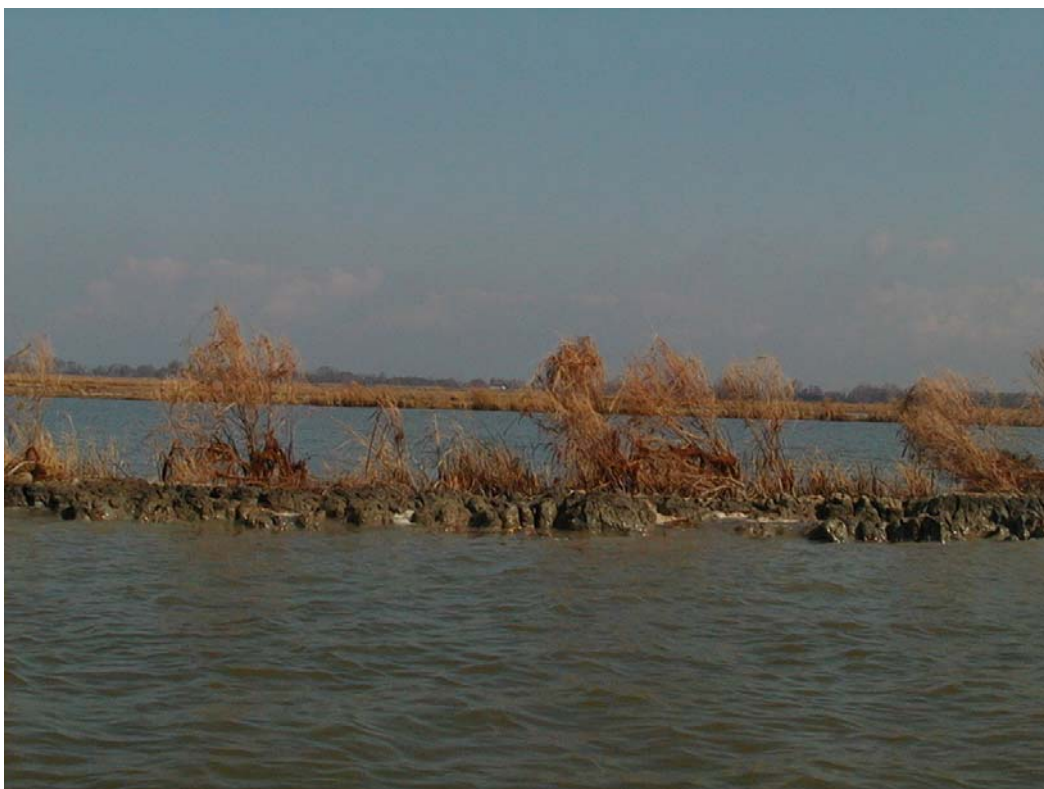
The vegetative plantings on the slopes of the earthen terraces have colonized significantly and are experiencing stress due to salt water inundation and hurricane force winds. On a separate field trip dated October 11, 2005, Monitoring Personnel identified the need for complete replacement of two (2) continuous recorders and two (2) staff gages within the project area. (Photos: Appendix B, Photo 2)

Photo 2, Typical eroded terrace.
